Manhole Inspection Summary

Manhole # S21II_005MH

Insp Date: **6/27/07 7:38 AM**

Location Address: **1629 WESTWOOD-PRESBURY**

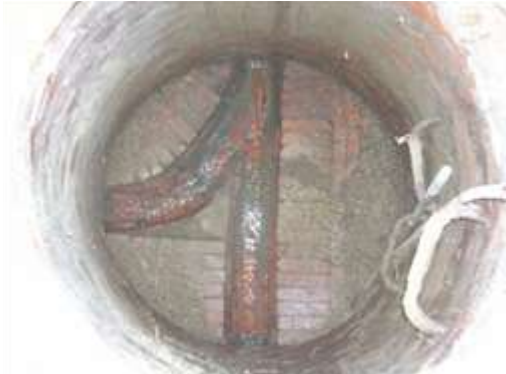
Defect 2

Infiltration: ☐ None ☐ Joint ☐ Cracks ☐ Mortar ☐ Roots ☒ Wall

INFILTRATION VISIBLE ON CORBEL WALL

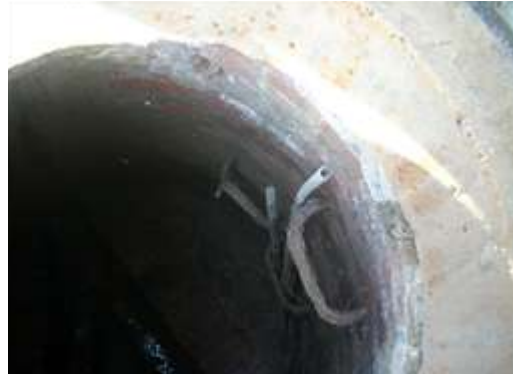
Defect 1

Count: **3** Missing: **1** ☒ Corroded

MISSING AND CORRODED STEPS

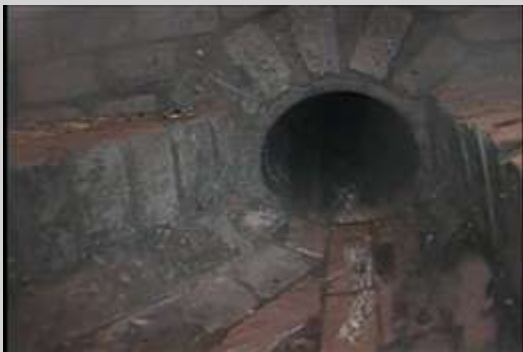
12 O'Clock Outflow

8 in. Circular Gravity Sewer
Pipe Out @ 12 O'Clock

Pipe Height: **8.4** (in.) Rod and Bar (Angled)
Pipe Material: **Clay** ☐ Pipe Lined
Invert Depth: **8.86** (ft.) Flow Characteristics: **Slow**
Deposits: ☒ None ☐ Mud ☐ Sludge ☐ Debris ☐ Grease
Silt Depth: (in.) Deposits Extent:
Infiltration: **None** Pipe Seal Cond: **Sound**

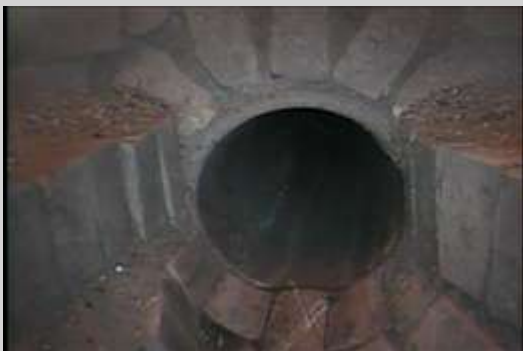
6 O'Clock Inflow

8 in. Circular Gravity Sewer
Pipe In @ 6 O'Clock

Pipe Height: **7.2** (in.) Rod and Bar (Angled)
Pipe Material: **Clay** ☐ Pipe Lined
Invert Depth: **7.59** (ft.) Flow Characteristics: **Slow**
Deposits: ☒ None ☐ Mud ☐ Sludge ☐ Debris ☐ Grease
Silt Depth: (in.) Deposits Extent:
Infiltration: **None** Pipe Seal Cond: **Sound**

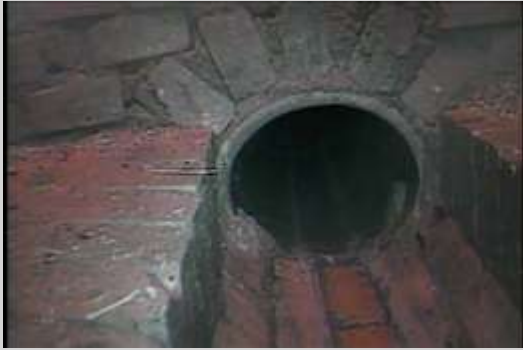
9 O'Clock Inflow

8 in. Circular Gravity Sewer

Pipe In @ 9 O'Clock

Pipe Height: **8.4** (in.) Rod and Bar (Angled)

Infiltration: **None** Pipe Seal Cond: **Sound**
